Rāmāñṛai Buddhist Complex at District Buner, Pakistan: Architectural and Hydrological Innovations in Gandhāran Buddhist Complexes

Zafar Hayat Khan / Abdul Samad Arshad Ullah / Asadullah Khan / Sabika Batool

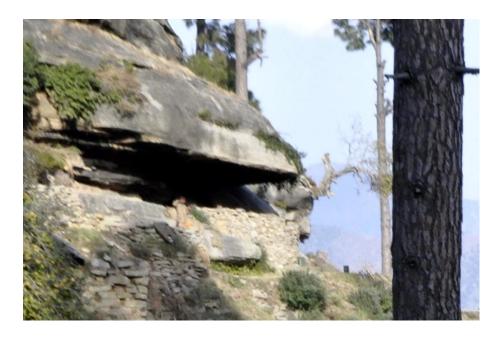
Fig. 3 - Rock shelter from pre-Buddhist period at Rāmāñṛai.

surveys reported several Pre-Buddhist caves, rock-shelters, and rock paintings, particularly on the steep slopes and under overhangs of Alak Sar/Gaṛhai Sar (Khan, Z.H. 2018: 142). Some of these rock-shelters may have later been re-occupied by Buddhist communities (Khan, Z.H. 2018: 146). One notable rock-shelter in the northern portion of the site, measuring approximately 4 by 2 meters internally, once bore ceiling paintings from Buddhist period (Khattak 1997: 74-77), though these have since been lost (Khan, Z.H. 2018: 142-146). According to Khattak the surviving wall within this shelter features floral, geometric, human, and faunal motifs that appear distinct from typical Buddhist iconography, suggesting a possible pre-Buddhist origin. Unfortunately, the ongoing use of this shelter as a kitchen by a nearby military post has threatened the preservation of this fragile artwork (Figs 3-4). Additional rock-shelters are located on the western side of the site, beneath steep granite cliffs which are provided with walls on its sides and lower portion (Figs 4-6).

Rāmāñṛai is among the most significant and large Buddhist sites in Buner District, notable for its extensive layout and massive architecture. The site is largely covered by massive granite boulders (Figs 3, 5-6), which have been integrated into its construction. Architectural remains of the site include a main stūpa, numerous small stūpas, surrounding chapels, isolated monastic cells, wells, a central water tank, a circular watchtower, underground chambers, corbelled double-storey buildings, stairways, bathrooms or tanks adjacent to springs, and massive retaining blockades constructed to prevent erosion. The western portion of the site, with its irregularly arranged structures, resembles a network of ancient streets and residential units (Khan, Z.H. 2018: 162-164).

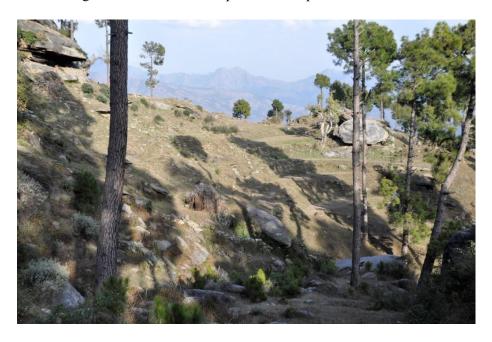
Fig. 4 - Rock shelter from pre-Buddhist period and the Buddhist period settlement in its surroundings.

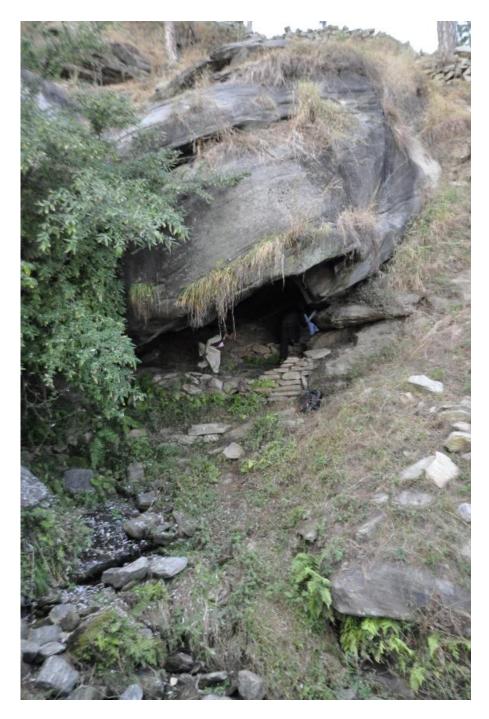
Fig. 5 - Rock shelter with spring, channel and structures inside.

Water management infrastructure at the site includes three active springs (Figs 5, 15) descending from Alak/Garhai Sar, which have been skillfully channeled through masonry conduits (Figs 5, 16-17). In addition, two wells and a large central water tank are present, likely used for rainwater collection or ritual ablution. A small bathroom structure is also located near one of the springs in the central area, featuring a doorway that opens into the spring, a floor paved with square slabs, and a central drainage channel.

Due to the site's steep terrain, steps are strategically placed throughout the area to facilitate movement (Fig. 18), while large masonry blockades have been constructed to mitigate erosion during heavy rainfall (Fig. 19). Other secular structures include houses, streets, underground chambers, and a watchtower. A notable underground chamber in the northeastern sector comprises a double-storey corbelled building (Fig. 20). The lower storey, still intact, features an arched doorway (Fig. 21) and a ventilator, while the upper storey has mostly collapsed. This chamber, adjacent to a spring and rock-shelter (Fig. 5), showcases the advanced engineering skills of the site's builders.

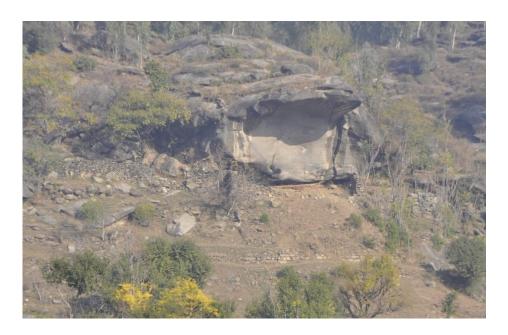
Fig. 6 - Rock shelter and granite boulders with structures on its sides.

Several monastic complexes have been identified to the southeast, east, and northeast of the main stūpa complex (Figs 12, 14). Although only partial remains of these monasteries survive today, the best-preserved example lies near the northern rock-shelter. However, part of this complex has been lost due to agricultural encroachment. The central and western parts of the site are dotted with rock-shelters, two of which contain built structures and internal steps, possibly used for storage (Fig. 6).

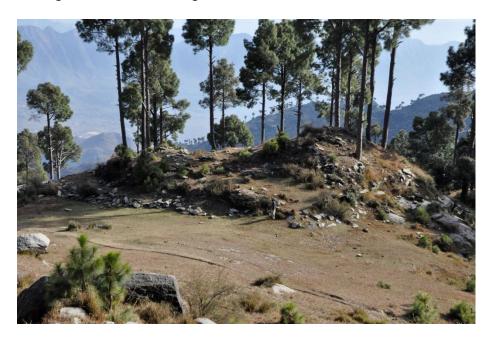
Fig. 7 - Main Stūpa Complex at Rāmāñṛai.

The stūpas at Rāmāñṛai are distributed in three primary areas: the main stūpa complex (Fig. 7), a group of small stūpas nearby (Fig. 8), and scattered individual stūpas across the site (Fig. 10). The main stupa complex, situated on a minor plain in the western sector, consists of two types of buildings standing atop a rectangular platform measuring approximately 24 by 14 meters and elevated two meters above the surrounding ground: a monumental stūpa and a circular structure that may be either a stūpa that has been hollowed out in search for relics in modern times or a circular shrine. Access is provided by staircases on the northern and eastern sides. The main stūpa (Figs 7, 9), now standing with a maximum height of c. 2.7 meters, occupies the western end of the platform, while the other circular structure, mostly destroyed by treasure hunters,

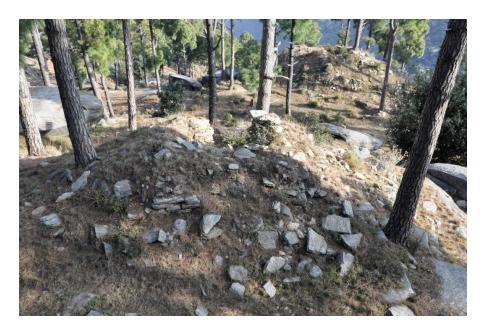
Fig. 8 - Small stūpas erected over huge boulders.

Surrounding the main stūpa complex, numerous small stūpas are built atop large boulders (Fig. 8), particularly toward the south, east, and northeast. Some of these boulders are naturally accessible, while others are equipped with steps. The small stūpas, typically with a square or round podium, have suffered significant damage due to natural weathering and smagglers' activity. Adjacent to these stūpas are small chapels measuring approximately 2 by 2 meters (Fig. 12), built either directly onto boulders or platforms that correspond to the original elevation of the main monument. Additional stūpas (Figs 10, 13), about six in total, are scattered across the southeastern and eastern portions of the site.

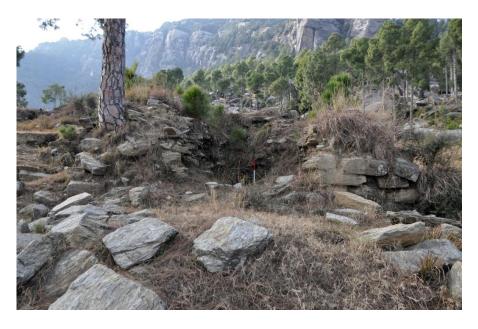
Fig. 9 - Robber pit at the drum of the Main Stūpa.

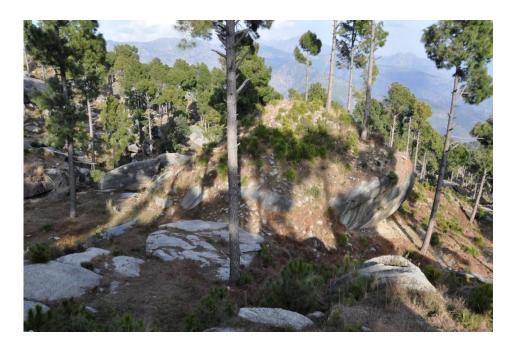
Fig. 10 - One of the scattered individual stūpas at Rāmāñṛai.

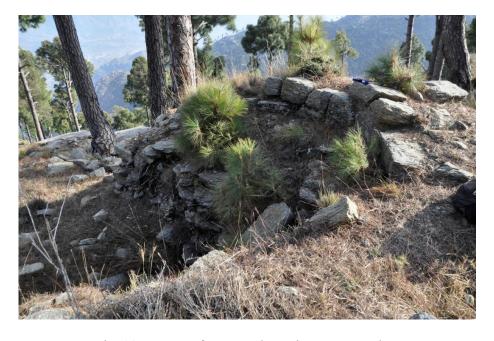
Fig. 11 - Traces of stūpa at the main stūpa complex.

lies on the eastern side. The latter preserves remnants of its base in the form of a double course of dressed stone blocks (Fig. 11).

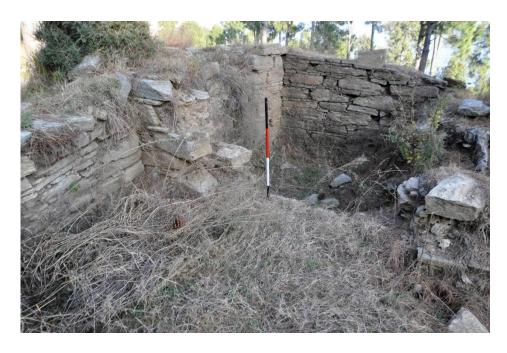
Fig. 12 - Parts of Monastic complex behind main stūpa.

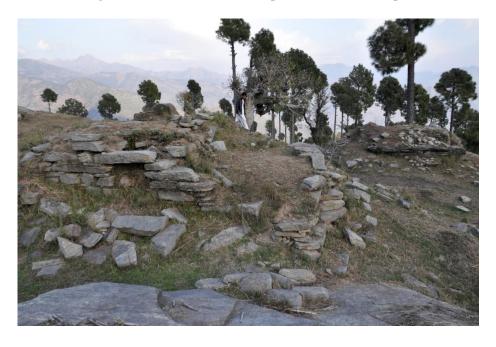
Fig. 13 - Other stūpas scattered in the eastern parts of the site.

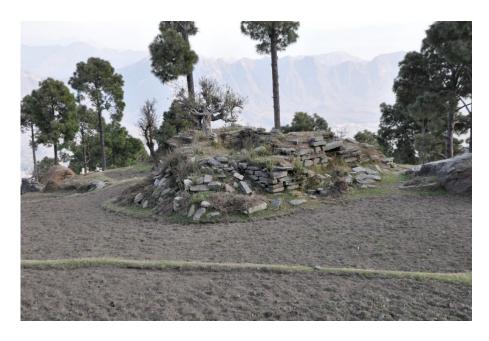
Fig. 14 - Parts of Another Monastic Complex at Rāmāñṛai.

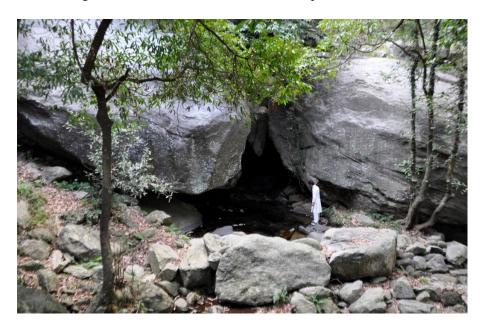
Fig.15 - One of Several Active Springs at Rāmāñṛai.

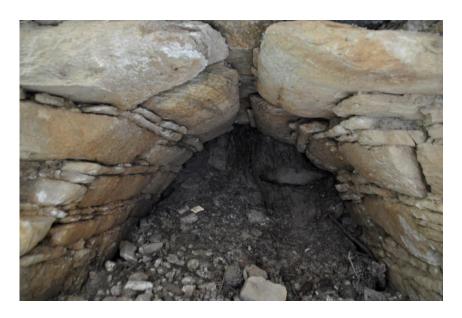
Fig. 16 - Roof of a Channeled Spring at Rāmāñṛai.

Fig. 17 - One of the roofed channels of water.

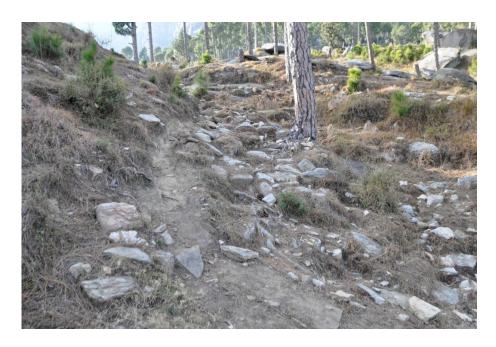
Fig. 18 - One of the damaged stairway at steep places of the site.

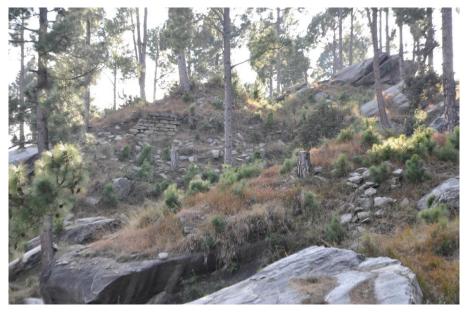
Fig. 19 - One of the embankment to support the structures and channel the floods.

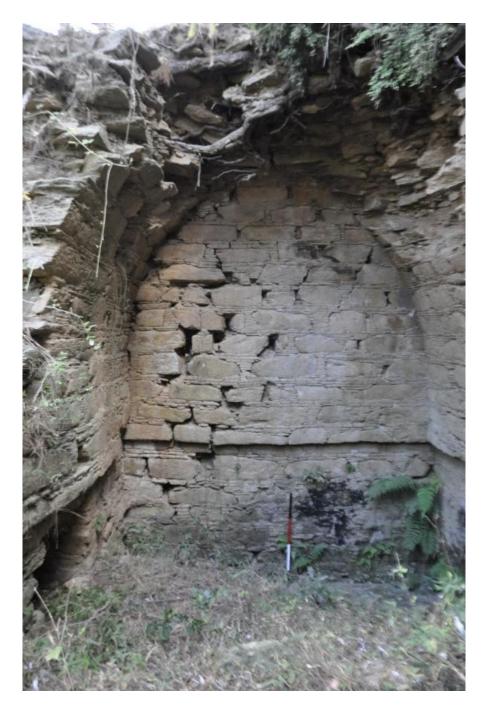
Fig. 20 - Corbelled Roof and Double-Storey Structure at Rāmāñṛai.

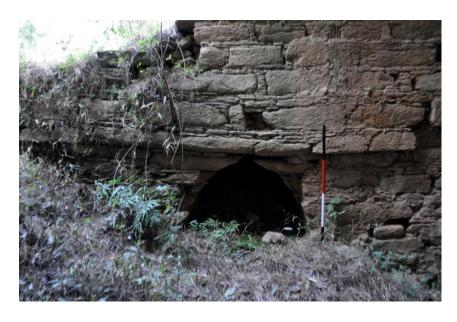
Fig. 21 - Arched doorway to the corbelled roofed double-storey structure.

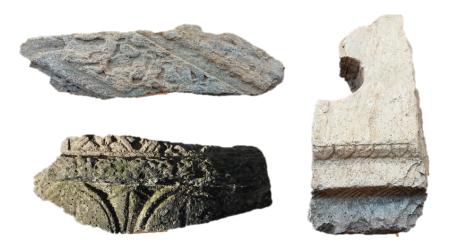
Fig. 22 - Fragments of a few architectural elements and materials observed at the site (not to scale).
